Issue 41

Winter 2001/2002

CONSIDERATIONS WHEN PAVING TREATED TIMBER BRIDGE DECKS

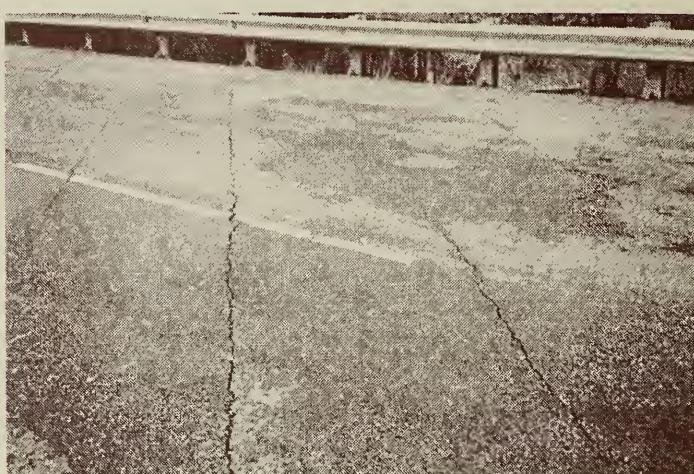
Asphalt paving is flexible enough that uniform bridge superstructure deflection seldom causes pavement problems. The most common cause of pavement failure in glued-laminated panel deck systems is differential deflections between adjoining deck panels. This is particularly true of transverse glued-laminated deck panel systems (the panels are installed with the laminations perpendicular to traffic flow). Wheel loads moving from panel to panel cause rapid, repetitive panel movement. When these deflections are greater than .05 inches the pavement will usually crack. When deflections exceed .10 inches the cracks will often ravel, causing impact loadings and increased moisture penetration and retention.

Figure 1. Pavement cracking caused by differential deflection of panels.

Designing stiffer glued-laminated panel decks, either through closer beam spacing or a thicker deck, will prevent deflection-induced pavement cracking. Traditionally, timber bridges were designed with flexible beams and stiff decks. The advent of glued-laminated timber allowed fabrication of deeper, stiffer beams. Larger beams encouraged greater beam spacing and more deflection in decks. Deeper deck panels minimize deflection and pavement cracking, but quickly increase the material cost of a timber bridge.

A more effective solution is often to mechanically interconnect the glued-laminated deck panels. The most common method of panel interconnection is the dowelled system developed by the USDA Forest Service Forest Product Laboratory in the 1970s. This system is described in the USDA Forest Service publication, *Timber Bridges: Design, Construction, Inspection, and Maintenance* [1]. A series of steel dowels are placed at the mid-depth of the glued-laminated panels. Design specifications are included in the American Association of State Highway and Transportation Officials, *Standard Specifications for Highway Bridges* [2].

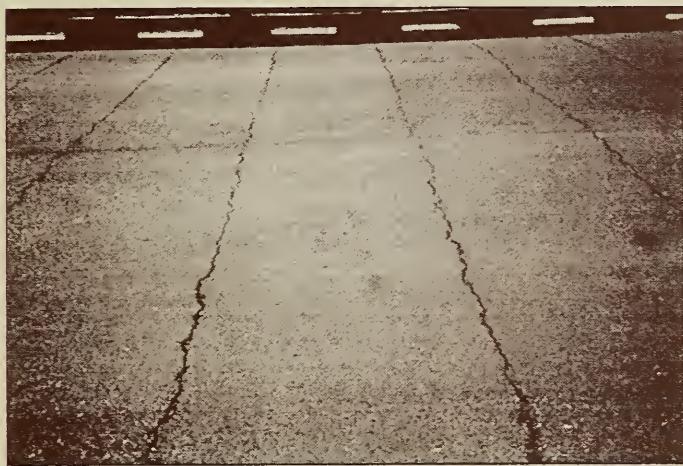
Glued-laminated deck panels are normally treated with oil-borne preservative treatments, thereby minimizing moisture penetration and the associated volume change. However, if deck panels are treated with waterborne treatments, or light oil solvent treatments in low humidity states, drying can cause enough deck shrinkage to crack asphalt paving at the panel joints. Deck panel expansion seldom causes pavement damage, but shrinkage of .125 inches per panel joint is enough to cause crack formation. A reduction in moisture content of as little as 3 percent can cause .375 inches of shrinkage in a 4-foot wide glued-laminated deck panel [4].

Figure 3. Pavement cracking caused by shrinkage of deck panels.

Unless glued-laminated deck panel deflection is limited to .05 inches, panels should be mechanically interconnected. Deck panels should be treated with an oil-borne preservative, and to minimize shrinkage, should be installed at moisture contents of 16 percent or less. Deck panels should be treated in compliance with the treatment Best Management Practices to minimize solvent and treatment chemical surface migration. The quantity of asphalt at the wood/asphalt-pavement interface should be minimized and paving membranes should not be placed in direct contact with oil-borne preservative treated wood.

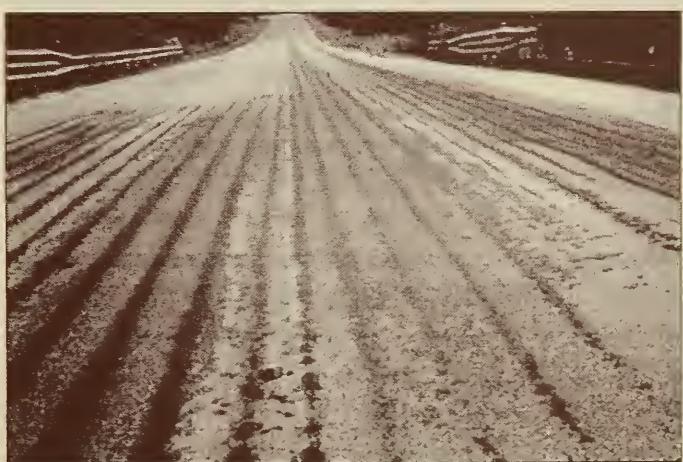
chemicals (and/or solvents) will be present at, or may migrate to, timber surfaces. These materials have detrimental effect on asphalt pavement. Excessive creosote or oil solvent reduces pavement to deck adhesion, softens the asphalt in the pavement mix, and causes bleeding and pavement rutting.

Figure 4. Bleeding caused by over treatment (note tracking from bridge to approach).

In 1994, the Western Wood Preservers Institute and the Canadian Institute of Treated Wood, in consultation with the USDA Forest Service, published a set of specifications for timber treatment. The latest edition of this publication, *Best Management Practices for the Use of Treated Wood in Aquatic Environments* [6] (BMPs) was printed in 1996. These specifications seek to minimize the amount of treatment chemicals available to migrate into the environment by controlling treatment procedures, mandating post treatment cleaning procedures, limiting chemical loading, and requiring visual inspection before installation. (The BMPs can be viewed at www.wwpinstitute.org/.)

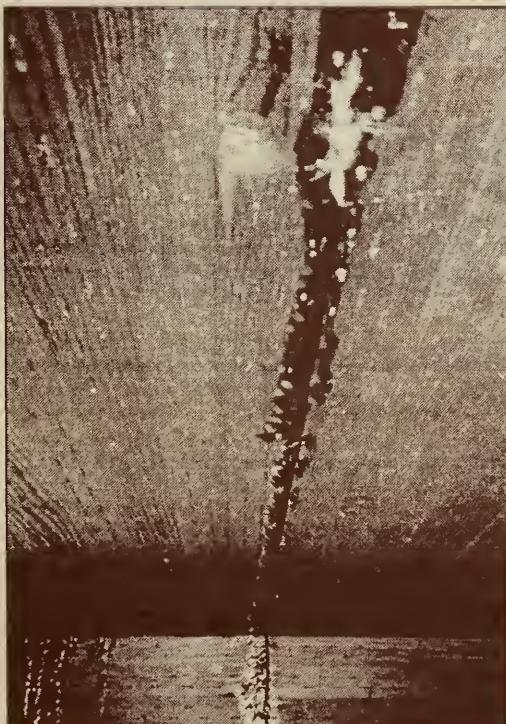
Over the past several years, incidents of asphalt material dripping from the underside of treated timber deck panels have been reported in Michigan and Oregon. In July of 2000, a creosote treated transverse glued-laminated timber panel deck bridge in Michigan was inspected and tested. The bridge had been paved in late November of 1998. Immediately after paving, strands of melted paving membrane were observed hanging from the underside of the bridge. The hot asphalt overlay melted the paving membrane causing this initial leakage. However, the membrane continued to leak from the underside of the bridge.

In early 2000, two Forest Service bridges in Oregon were reported to be leaking asphalt material between the deck panels. One bridge had been installed in 1991, the other in 1998. In each case the leakage was not observed until the bridges were inspected in the fall of 1999. Deck panels for the 1991 bridge were treated with pentachlorophenol in a light oil solvent. The deck had been coated with an asphalt primer before installing the paving membrane and asphalt pavement. The deck panels for the 1998 bridge were treated with pentachlorophenol in heavy oil and again coated with a primer before placing the membrane and asphalt pavement.

The creosote and pentachlorophenol treatment solvents in all these bridge decks appear to be dissolving the asphalt in the paving membranes. The Michigan bridge deck panels were not post treatment cleaned, and significant quantities of creosote were present on the panel surfaces. For the Michigan bridge, it appears that the paving membrane began to dissolve almost immediately after placement of the overlay. The Oregon bridges were post treatment cleaned and the dissolved membrane leakage did not appear until

Figure 5. Paving membrane leakage.

Paving membranes should not be placed directly against oil-borne preservative treated wood; however, they can be used over a base layer of asphalt. A crowned 1.5- to 2-inch layer of asphalt should be placed directly on the treated timber bridge deck. The paving membrane is then applied, and a final 1.5- to 2-inch layer of asphalt is placed over the membrane [8].
